HOTEL BUILDING RELIABILITY TOWARDS BUILDING AGE

Abstract: Mahara Hotel is a tourism-supporting facility and infrastructure first established in Central Aceh District in 1999. This 3-story hotel used a reinforced concrete frame structure, and as time goes by, the service capacity of the building would decrease. This condition was suspected to affect quality and user convenience. Anticipate the older age of the building, and better maintenance management is applied so that the proper building's function can be maintained. The purpose of this study was to assess the reliability of 20 year-established hotel buildings. The method was a descriptive analysis. Data were analyzed based on the guidelines of Technical Procedures for Guidelines for Certificate of Eligibility for Functions (SLF) of Buildings Regulation of Minister of Public Works No. 25/PRT/M/2007. Based on the results, the reliability value of the Mahara Hotel building was unreliable (66.75 %), less than the SLF guidelines (at least 75 %). Some components that caused a low level of reliability to include utility and fire protection components (20.34 %) and accessibility components (3.11 %). The effective and efficient compone

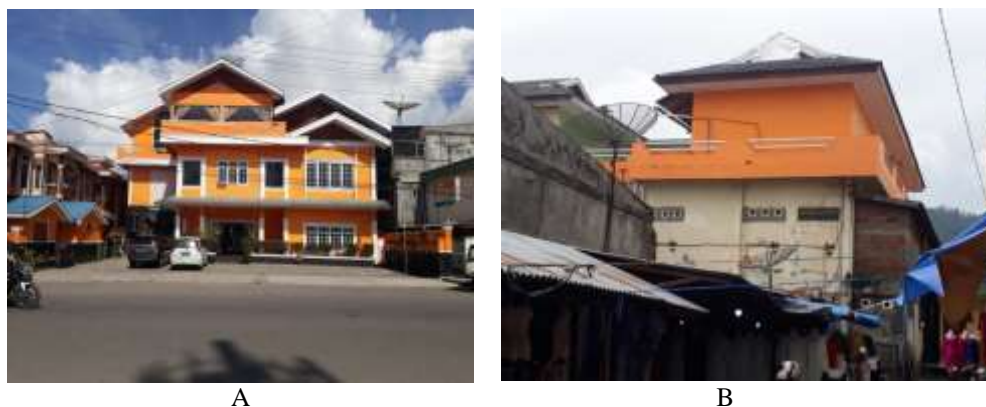
Figure 2. A. Overall architectural reliability condition. B. Architectural damage conditions

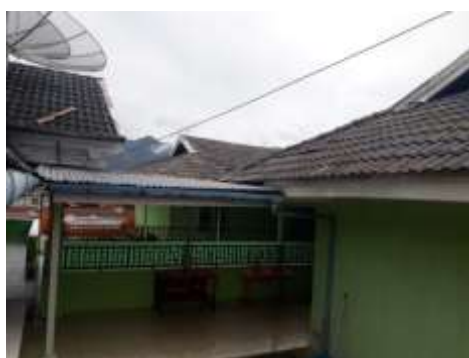
A

The resulting utility and fire protection components reliability calculation of the Mahara Hotel building was **40.68 %**, concluded as an **unreliable** category since the value was less than 85 % according to the specified reliability value requirements.

Figure 3. Condition of utility and fire protection. A. Lack of lightning protection facilities.
B. Lack of fire-fighting sprinkler facilities

The value of each component reliability of Mahara Hotel building can be used as an indicator of whether Mahara Hotel building management needs to be followed up to improve aspects of each component, which does not meet the requirement of building reliability. This case especially in the elements of utility and fire protection and accessibility. Although the results of Mahara Hotel building, structural reliability assessment were categorized as **reliable (94.13 %)**, however, it is necessary to maintain and repair some parts of the structure. Based on crack data that occurs in several parts of the beam structure of the 2nd-floor meeting room, repairation should be done immediately. Several repairation methods, i.e., crack epoxy injection and Carbon Fiber Reinforcement Polymer (CFRP), can be utilized as an alternative (Antonius et al., 2009; Budio et al.). However, this type of improvement is only for restoring the initial conditions, not for changing or increasing the strength of the structure itself.

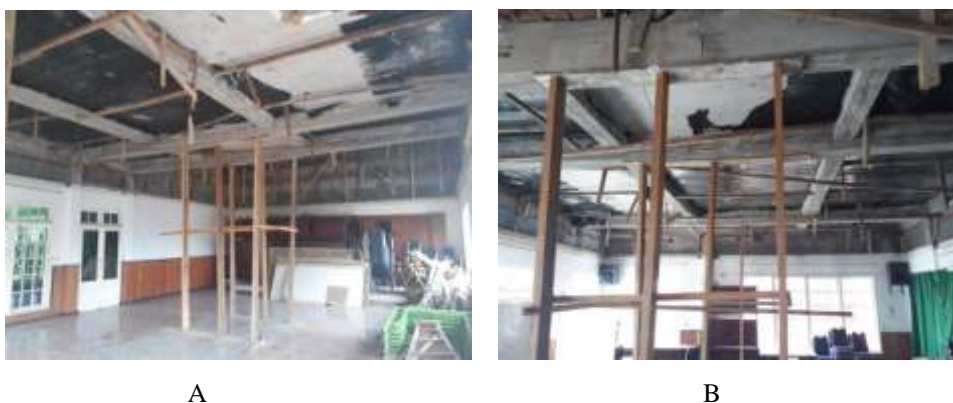
The results of Mahara Hotel building structural reliability analysis was **95.45 %**, concluded in a **reliable** category according to the specified architectural reliability values of 95 to 100 %.

Figure 4. Structural reliability condition A and B. Damage is in the beam components located in the hotel conference room (deflection and cracking).
